CAVE BUTTES DAM FOUNDATION REPORT GILA RIVER BASIN:
PHOENIX ARIZONA AND VICINITY (INCLUDING NEW RIVER)(U)
ARMY ENGINEER DISTRICT LOS ANGELES CA AUG 83

20. ABSTRACT (Continue on reverse side if necessary and identify by block number) A summation of the foundation exploration and subsequent foundation treatment and grouting program during construction of Cave Buttes Dam near Phoenix, Arizona. Includes 94 photos and 58 plates.

CAVE BUTTES DAM
FOUNDATION REPORT

U.S. ARMY, CORPS OF ENGINEERS
LOS ANGELES DISTRICT
AUGUST 1983

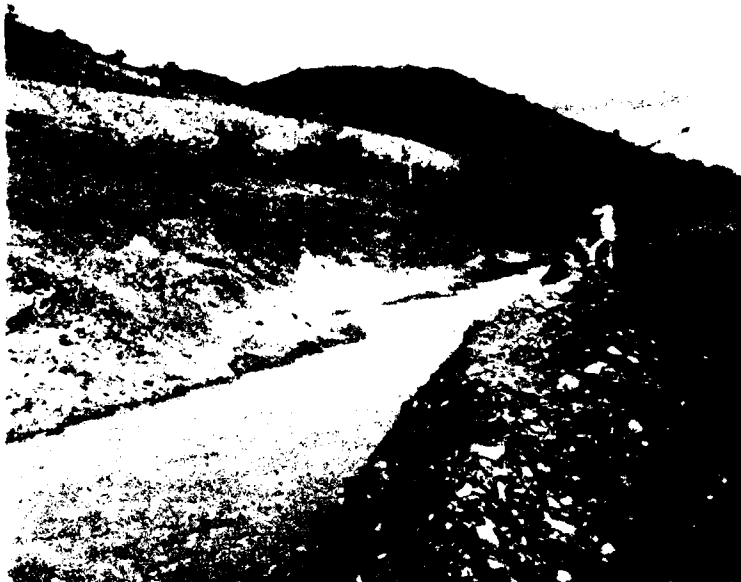
Photo 3 Diversion of water through construction,
toe of right abutment, upstream of center-
line of dam.

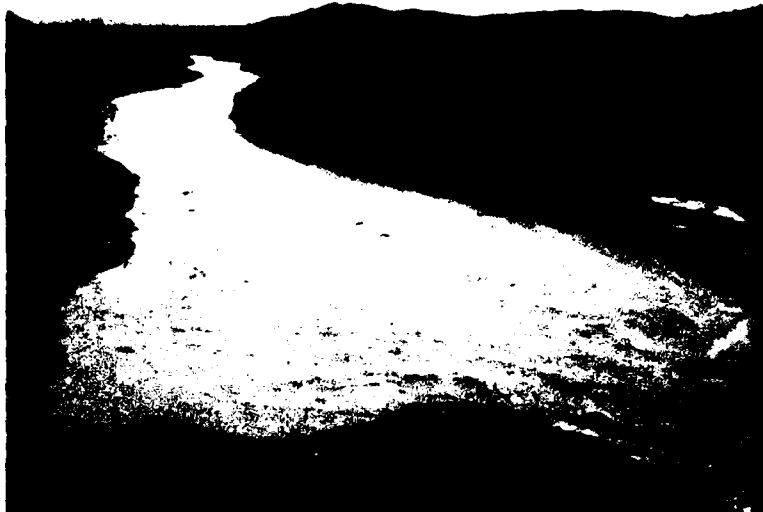
Photo 5 Diversion of 1500 cfs along toe of right abutment. View is up channel to the north.
2 Mar 78

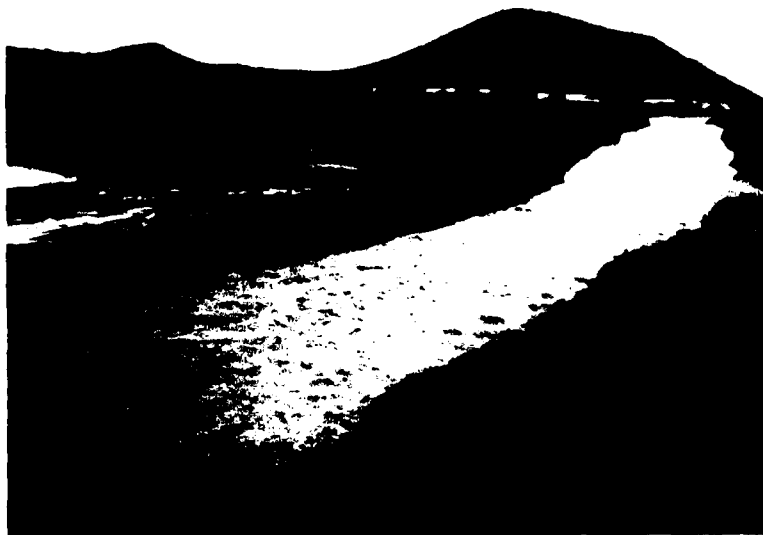
Photo 6 Diversion of 1500 cfs along toe of right abutment. View is down channel to the south.
2 Mar 78

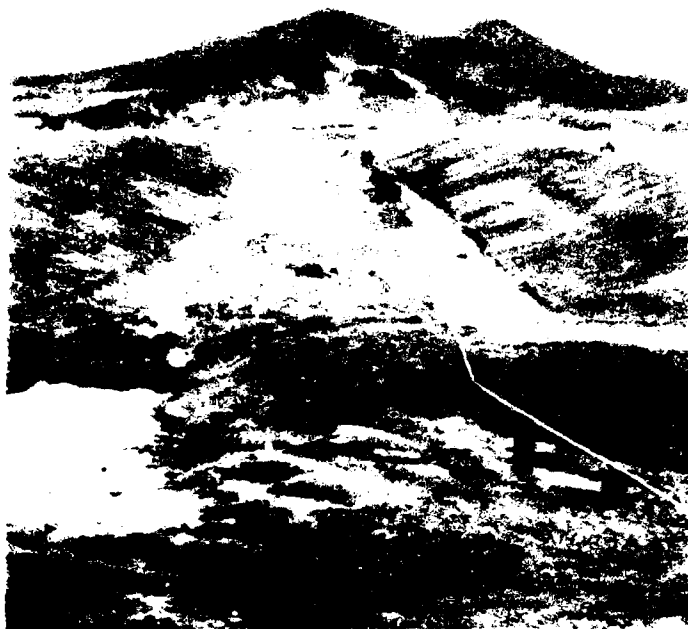
Photo 7

Core trench. Looking east from top of diversion dike. Contractor trying to remove water from trench.

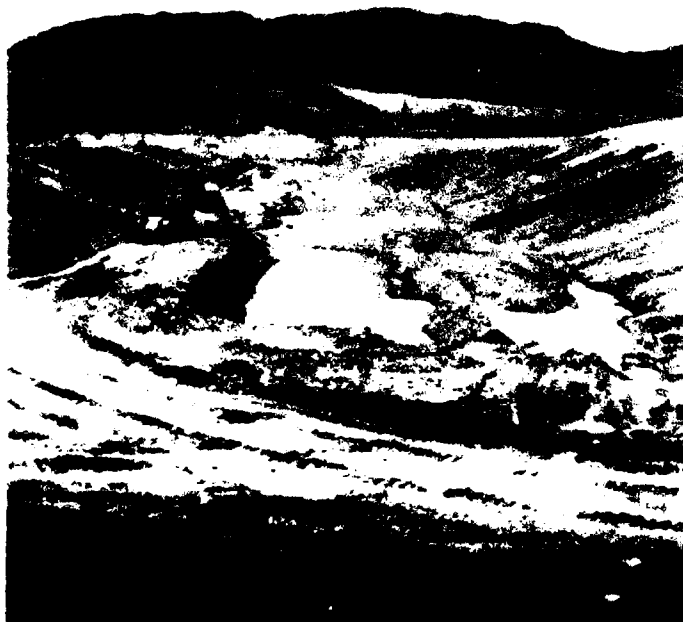
Photo 8

Core trench. Looking west. Contractor trying to drain water accumulated from rain and seepage.

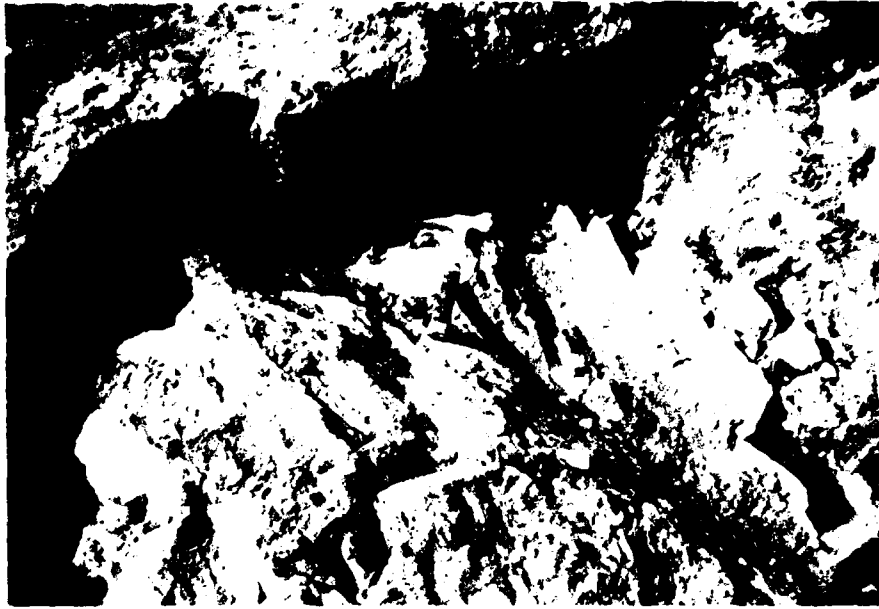
Photo 9 Slight seep at elevation 1,538± in downstream part
of cutoff trench, near right abutment.

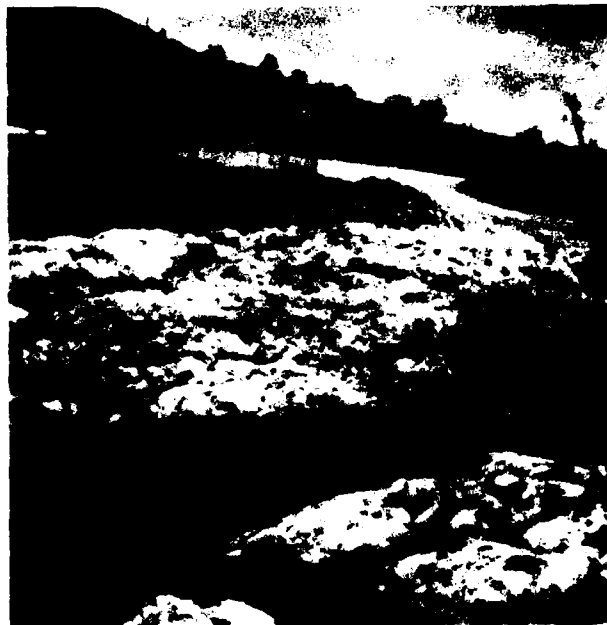
Photo 10

Seep in bottom of
cutoff trench at rock
knob, Sta. 27+50.

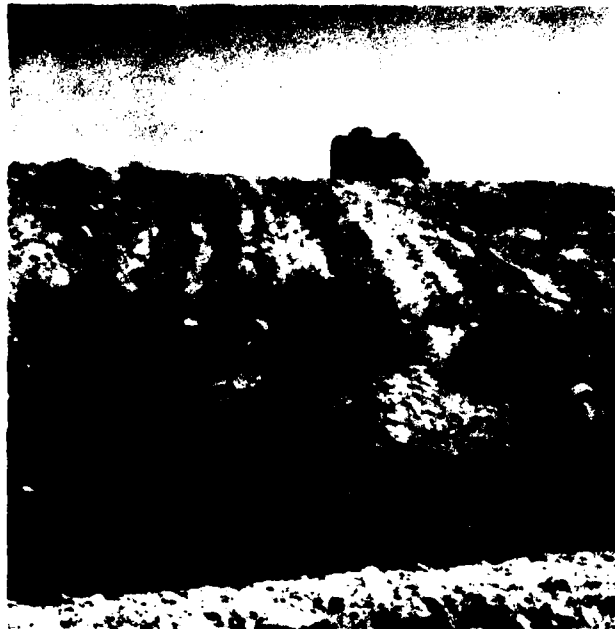
Photo 11

Downstream side of
cutoff trench, Sta.
21+05. Salt cedar
growth along seepage
at top of bedrock.

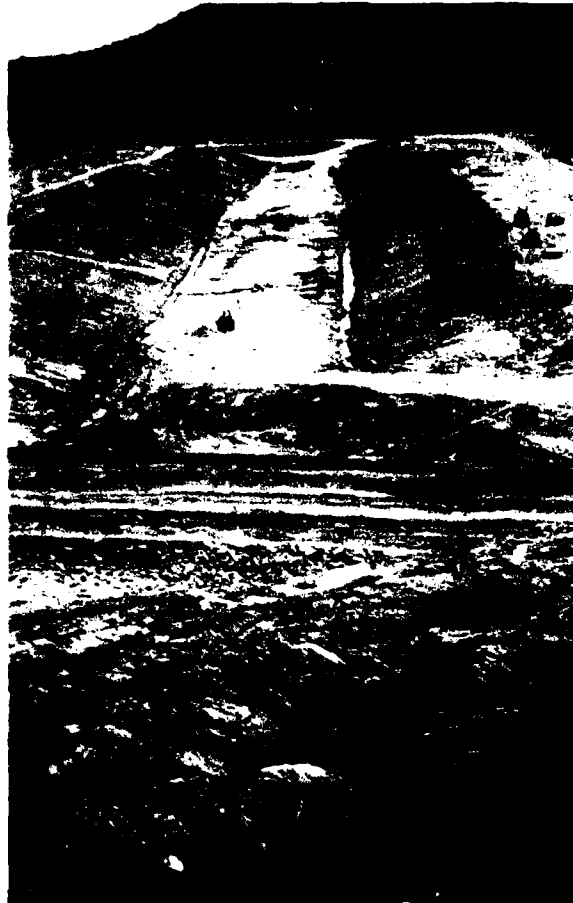
Photo 25

Left abutment to distant right abutment. View of cutoff trench. Grouting in center at Sta. 23+20.

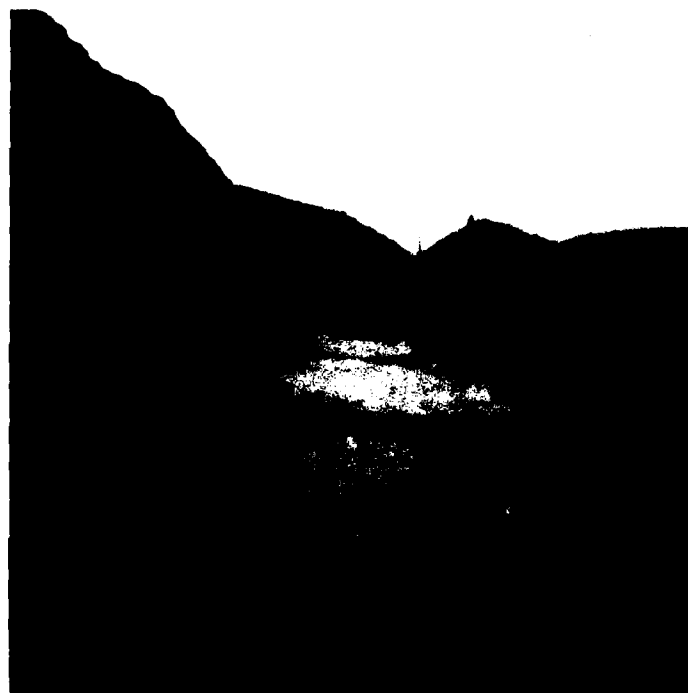
Photo 34

Outlet Works.
Base for conduit.
View downstream
from Sta. 51+50.

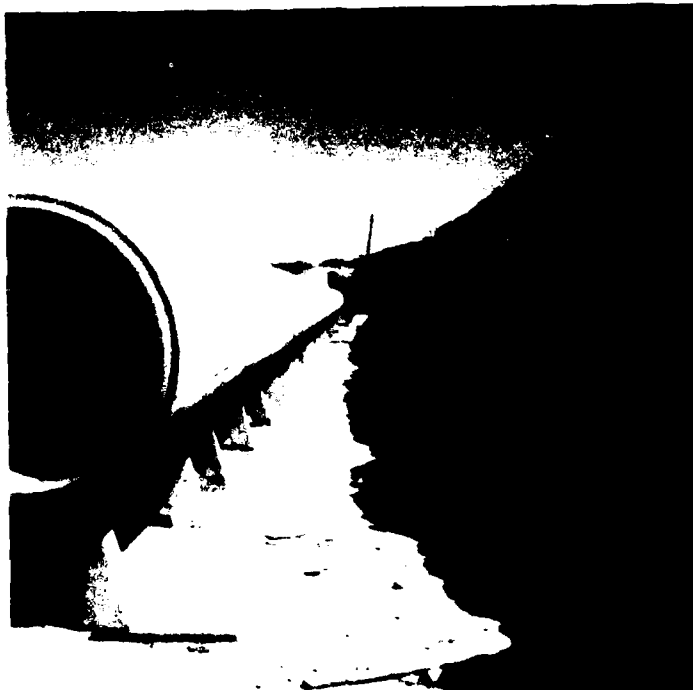
Photo 35

Outlet Works.
Setting conduit,
view upstream from
outlet Sta. 51+50.
6 Apr 78

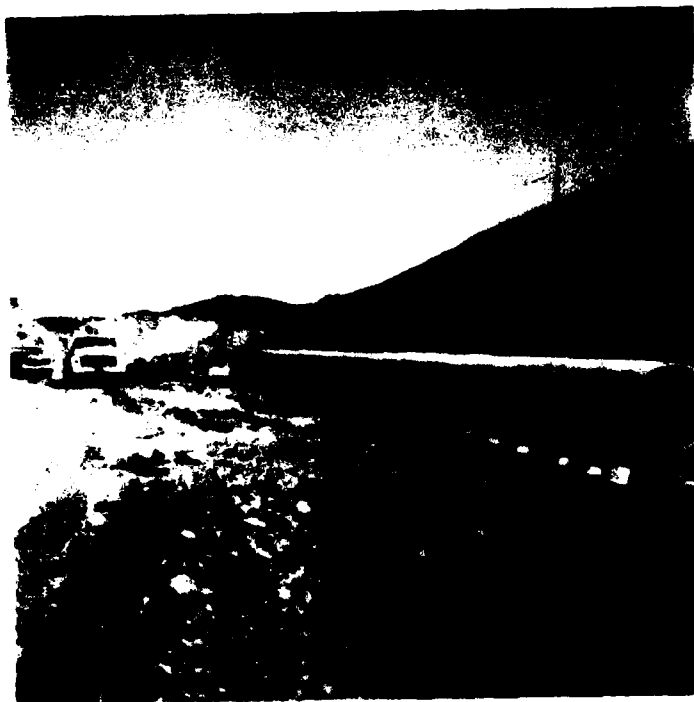
Photo 36

36. Outlet works. Same as photo 35 except view is along the west side. 6 Apr 78.....	51
37. Outlet works. Sta. 50+00 after cleaning and before setting forms for backfilling with lean concrete. 24 Apr 78.....	52

Outlet Works.
Same as photo 35
except view is along
the west side.
6 Apr 78

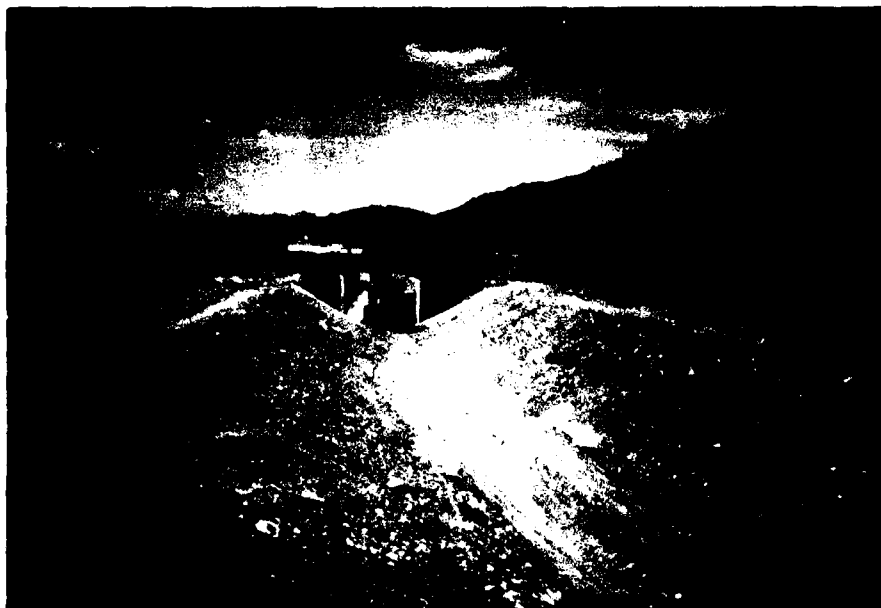
Photo 40 Outlet Works. Downstream portal and excavation for outlet channel.

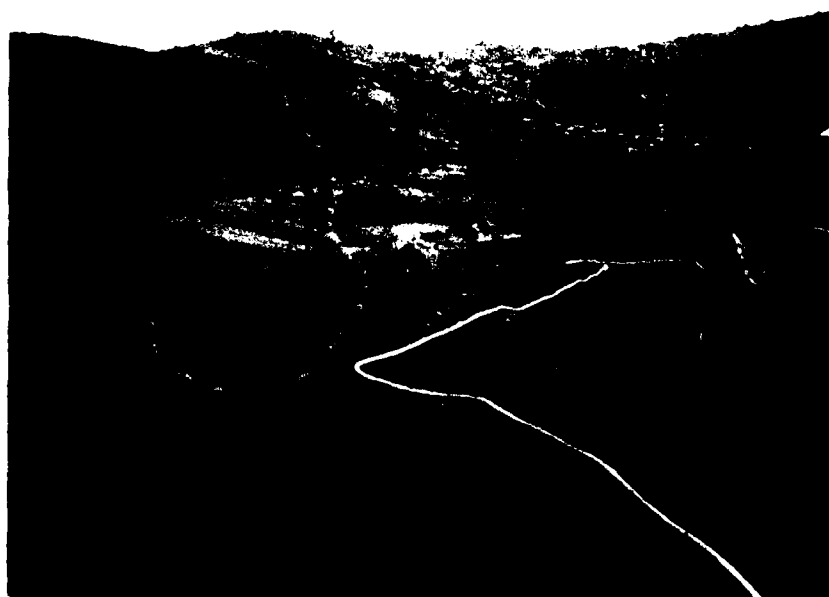
Photo 42 Dike No. 1, looking east.

5.05 Dike No. 1. After removing the top few feet of soil, the exposed bedrock consisted of highly fractured reddish brown to a drab green schistose greenstone. No scaling was necessary to flatten the slopes before any surface treatment was done. After the soil and approximately 2 feet of weathered bedrock was removed, the surface was blown off with high pressure air to prepare the surface for grouting. See Photos 41 through 44.

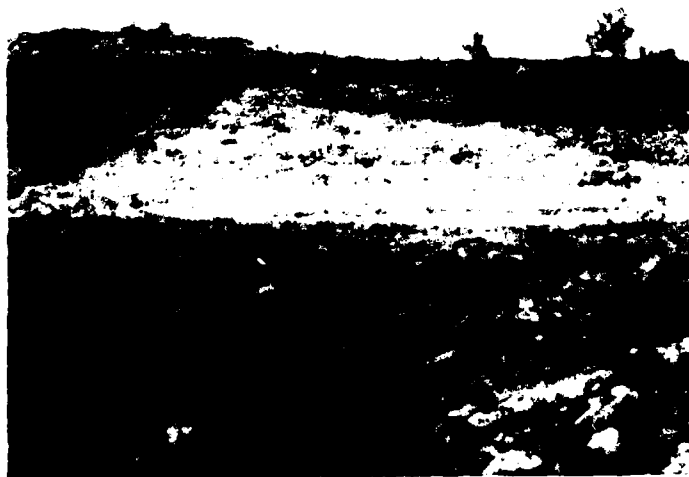
Photo 46

5.06 Dike No. 2. After removing the top few feet of soil and weathered bedrock on the right abutment, the exposed bedrock was highly fractured and was similar to that of Dike No. 1. No further excavation was required. The surface was blown off with high pressure air to prepare the surface for grouting. See Photos 45 and 46.

Dike No. 2.
Right side after
excavation half
way up abutment.

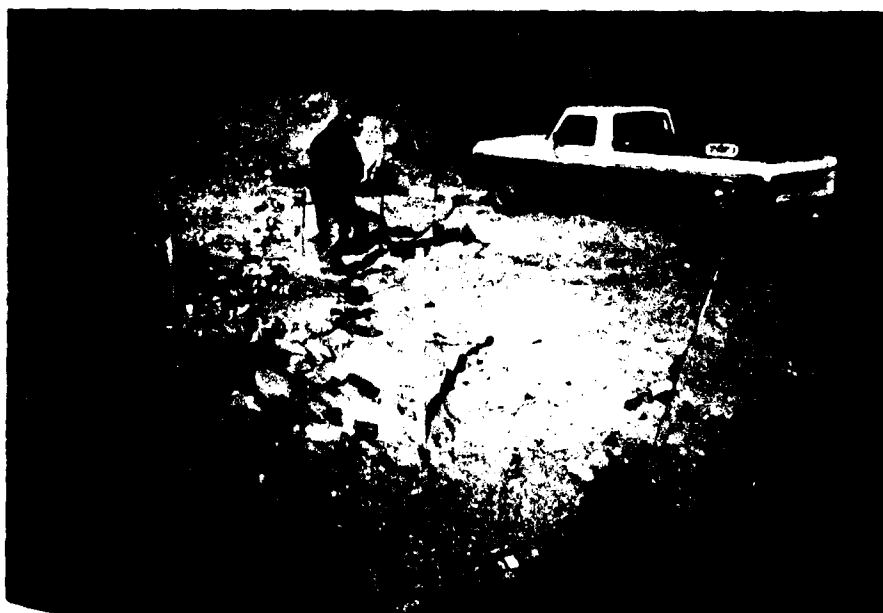
Photo 56 Spillway crest. Controlled blasting for sill trench. Charges are set in alternate holes which are line drilled on 1-foot centers to 5 foot depths.

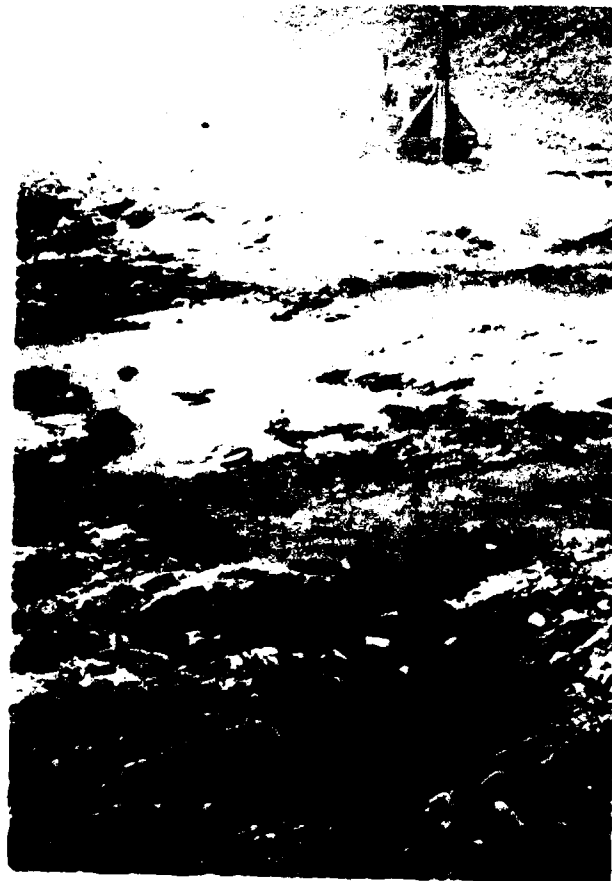
Photo 64

Cutoff trench.
Drilling grout hole.
Water puddle is from
drilling operations.
